METALLOGRAPHIC AND FRACTOGRAPHIC EXAMINATION

OF 7079 ALUMINUM ALLOY TEST SPECIMENS

THE BOEING COMPANY

**Prepared under Contract No. NAS 1-6474
by
THE BOEING COMPANY
Renton, Washington
for
NATIONAL AERONAUTICS AND SPACE ADMINISTRATION**

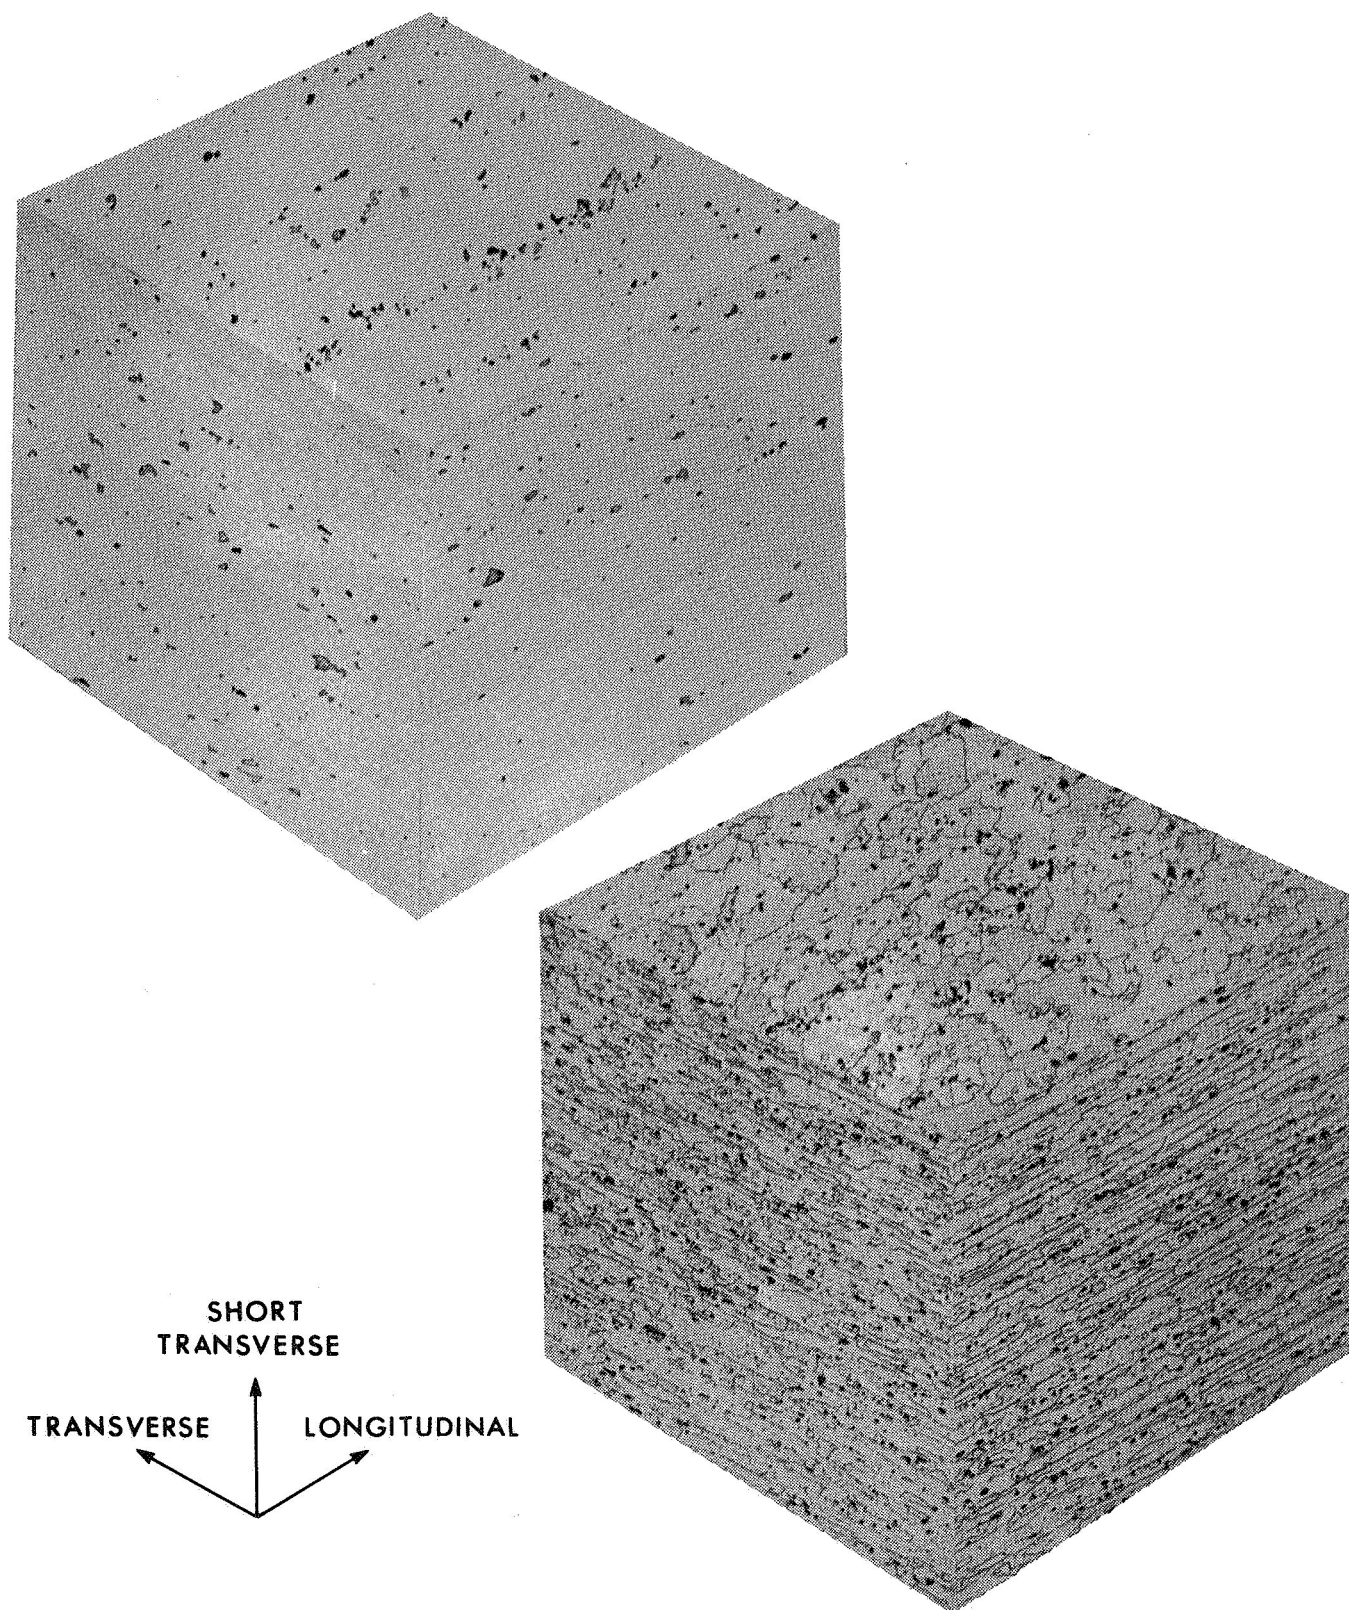
The material, with thicknesses of 0.160, 0.250, and 0.500 inch, exhibited the expected general grain structure characterized by elongated grains parallel to the rolling plane (figures 1, 2, and 3). Grain size, intermetallic distributions, and etching response were consistent throughout the thickness. Etching streaks parallel to the rolling plane in the lightly etched transverse sections are due to bands of small chromium and manganese intermetallics. These bands occur in all 7000-series aluminum alloys that contain these two elements. The bands are uniformly distributed throughout all of the 7079 aluminum alloy and there is no indication that their presence would have any effect on the mechanical or fracture test results.

Figure 1. Light and normally etched microstructures of 0.160-inch-thick material in the underaged condition (Magnification 86.5X)

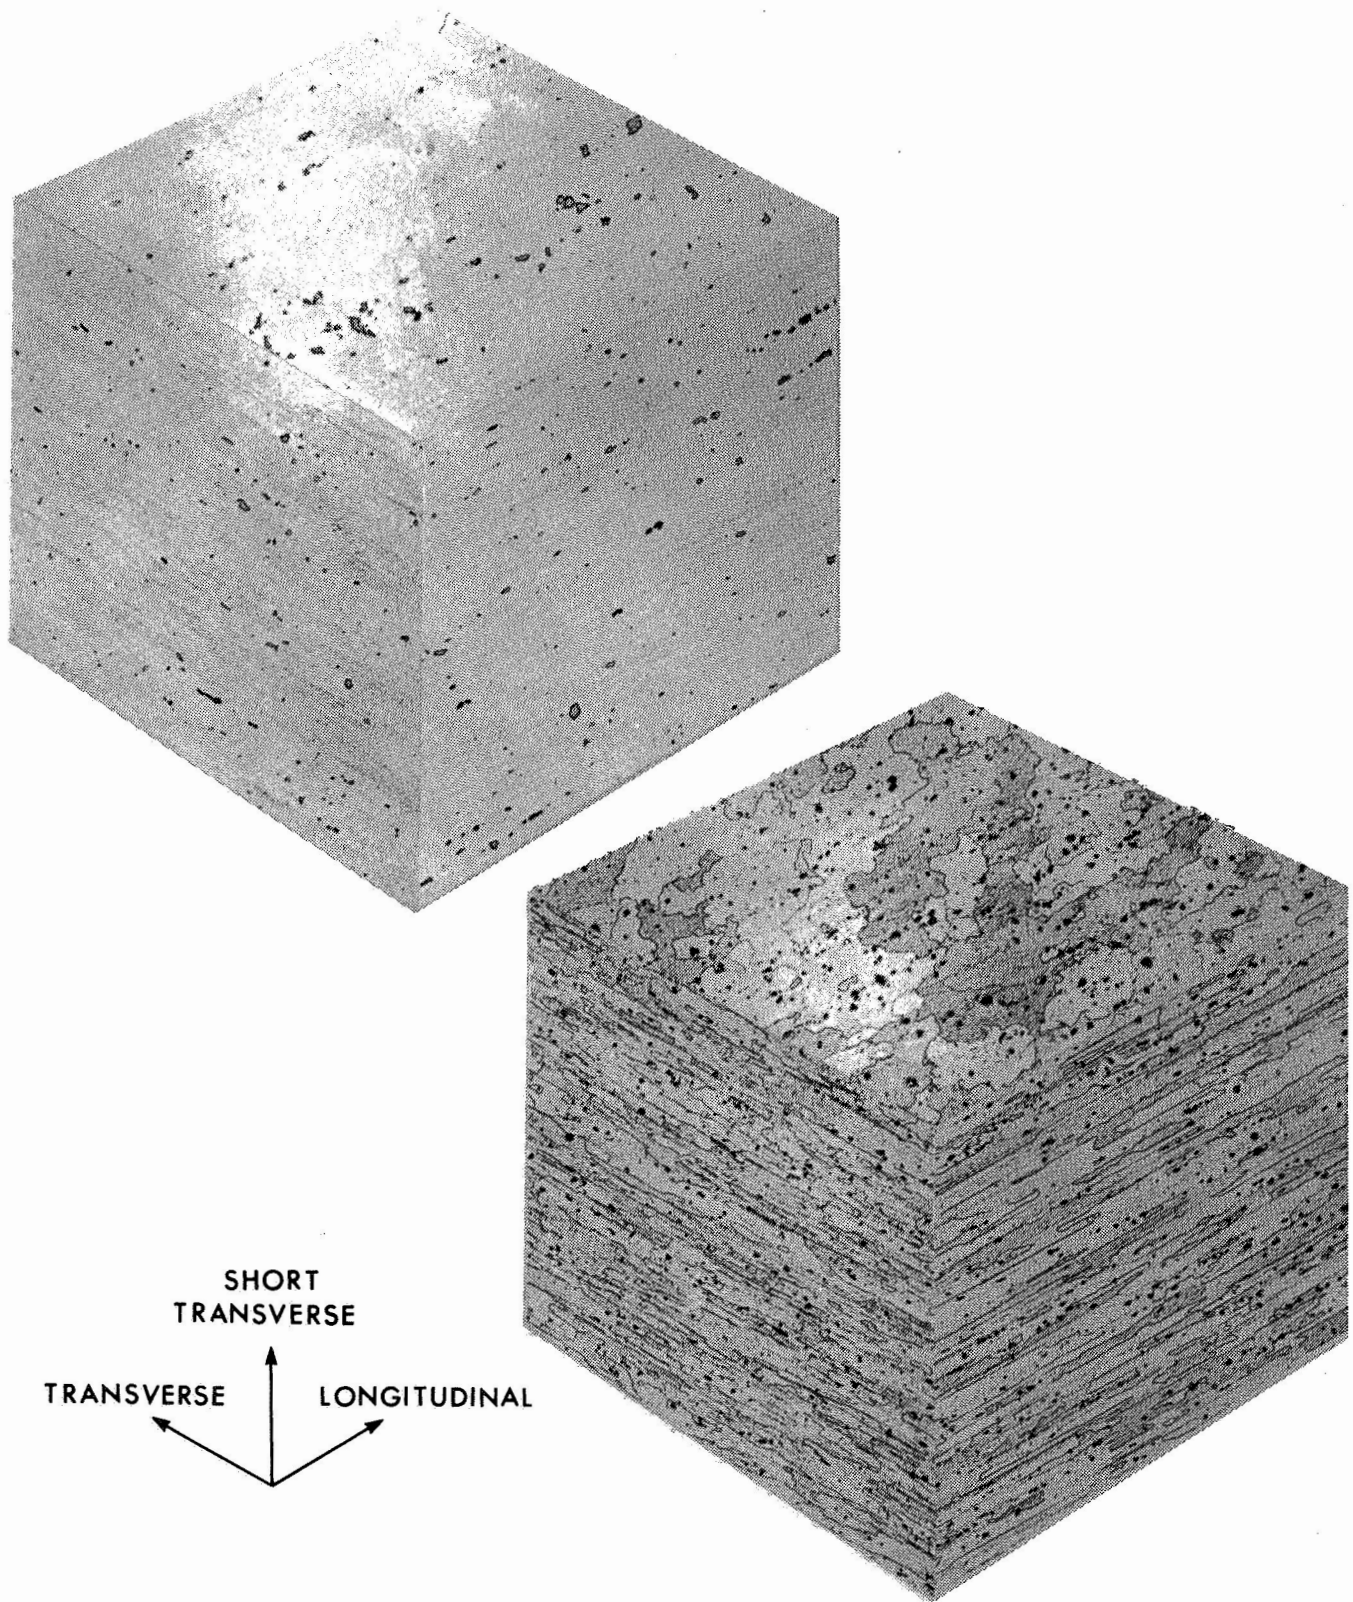
The effect of aging on microstructure was examined in the 0.25-inch-thick material and the results are shown in figures 2, 7, 8, 9, 10, and 11. No effect of aging is apparent in the very lightly etched specimens; however, it can be seen that increased aging greatly increases the etching response when more heavily etched. This was expected since increased precipitation results in increased chemical activity when the etchant is applied. Compare figures 9, 10, and 11 and observe that the definition of grain boundaries increases with aging time because of increased grain boundary precipitation and that some grains in the overaged specimen show a very heavy etching response. This difference in etching response from grain to grain is due to a lack of complete recrystallization and generally increases with the degree of aging. The fact that the 0.63-inch material showed this banding at midthickness in the underaged condition indicates that a smaller amount of the material had recrystallized.

Figure 2. Light and normally etched microstructures of 0.250-inch-thick material in the underaged condition (Magnification 86.5X)

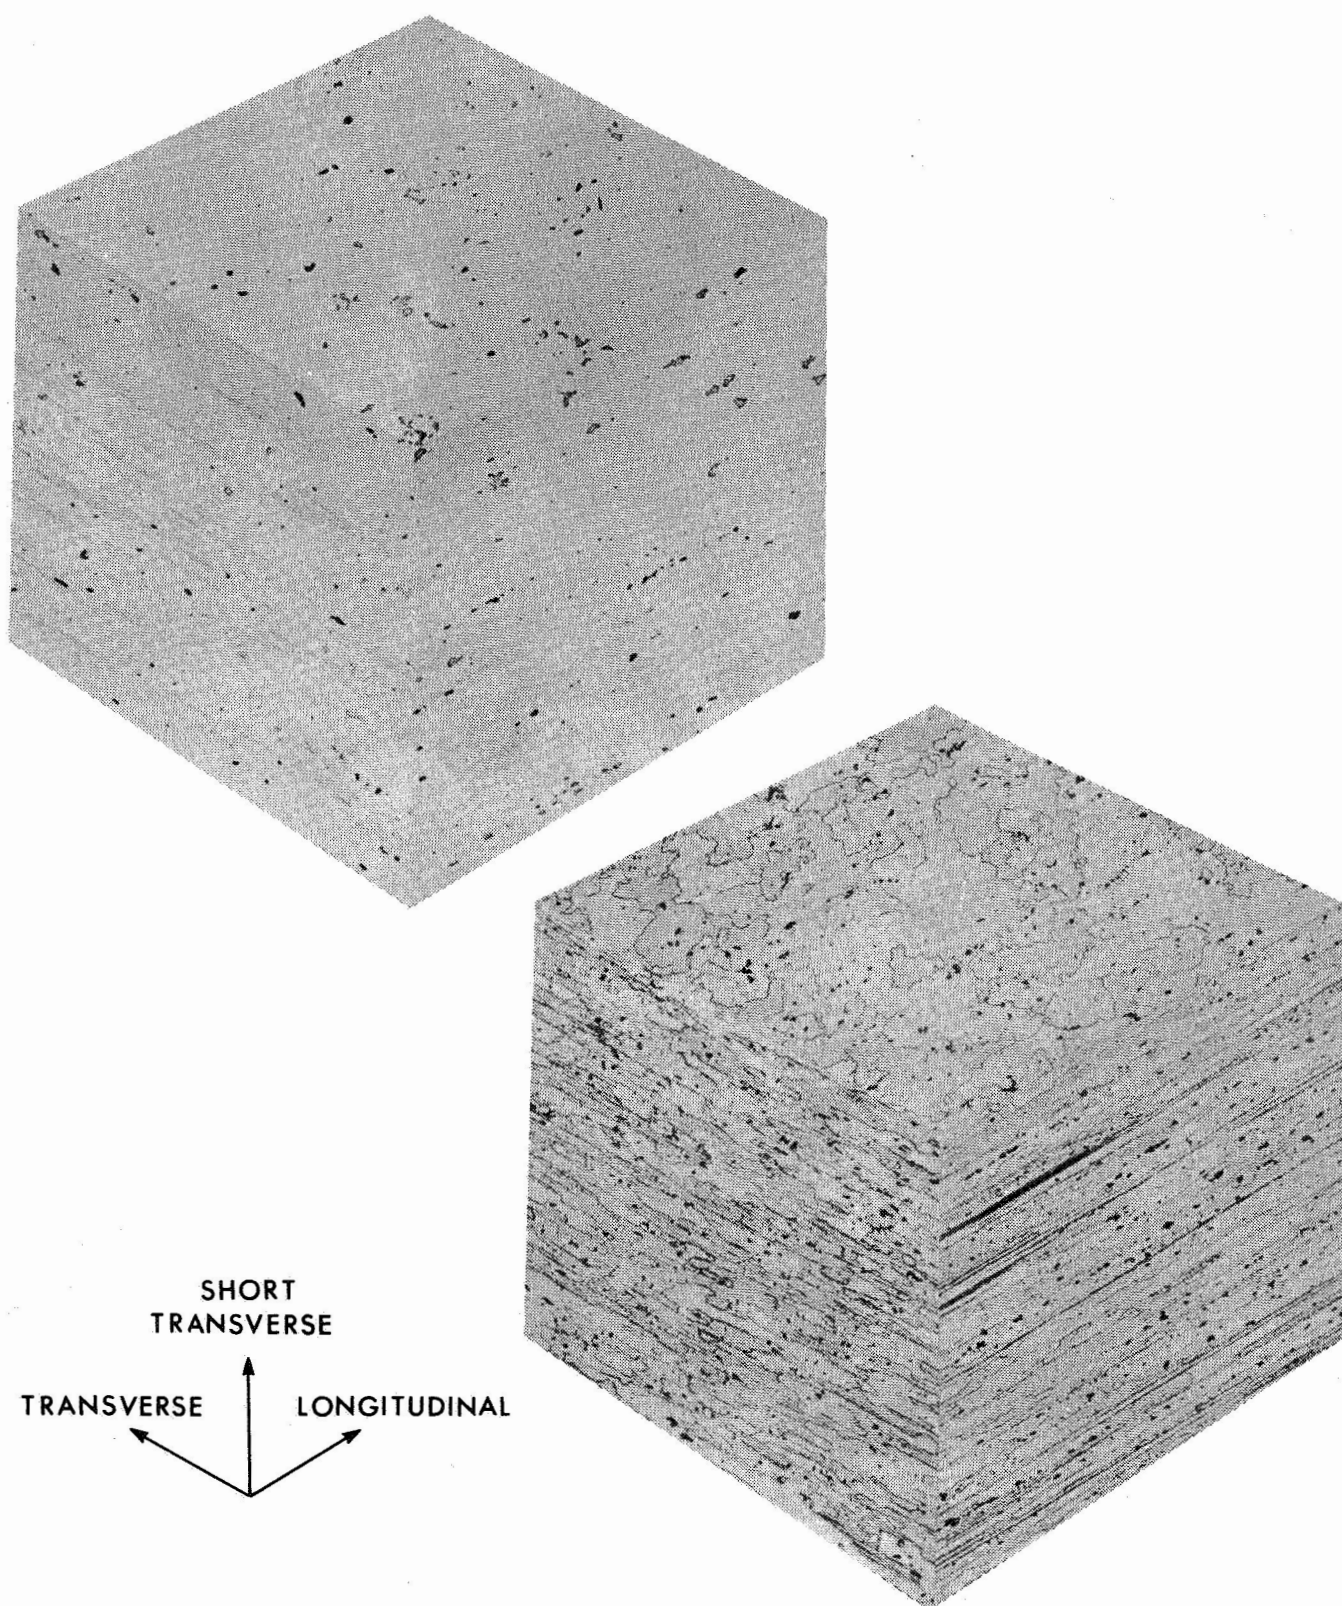
Figure 3. Light and normally etched microstructures of 0.500-inch-thick material in the underaged condition (Magnification 86.5X)

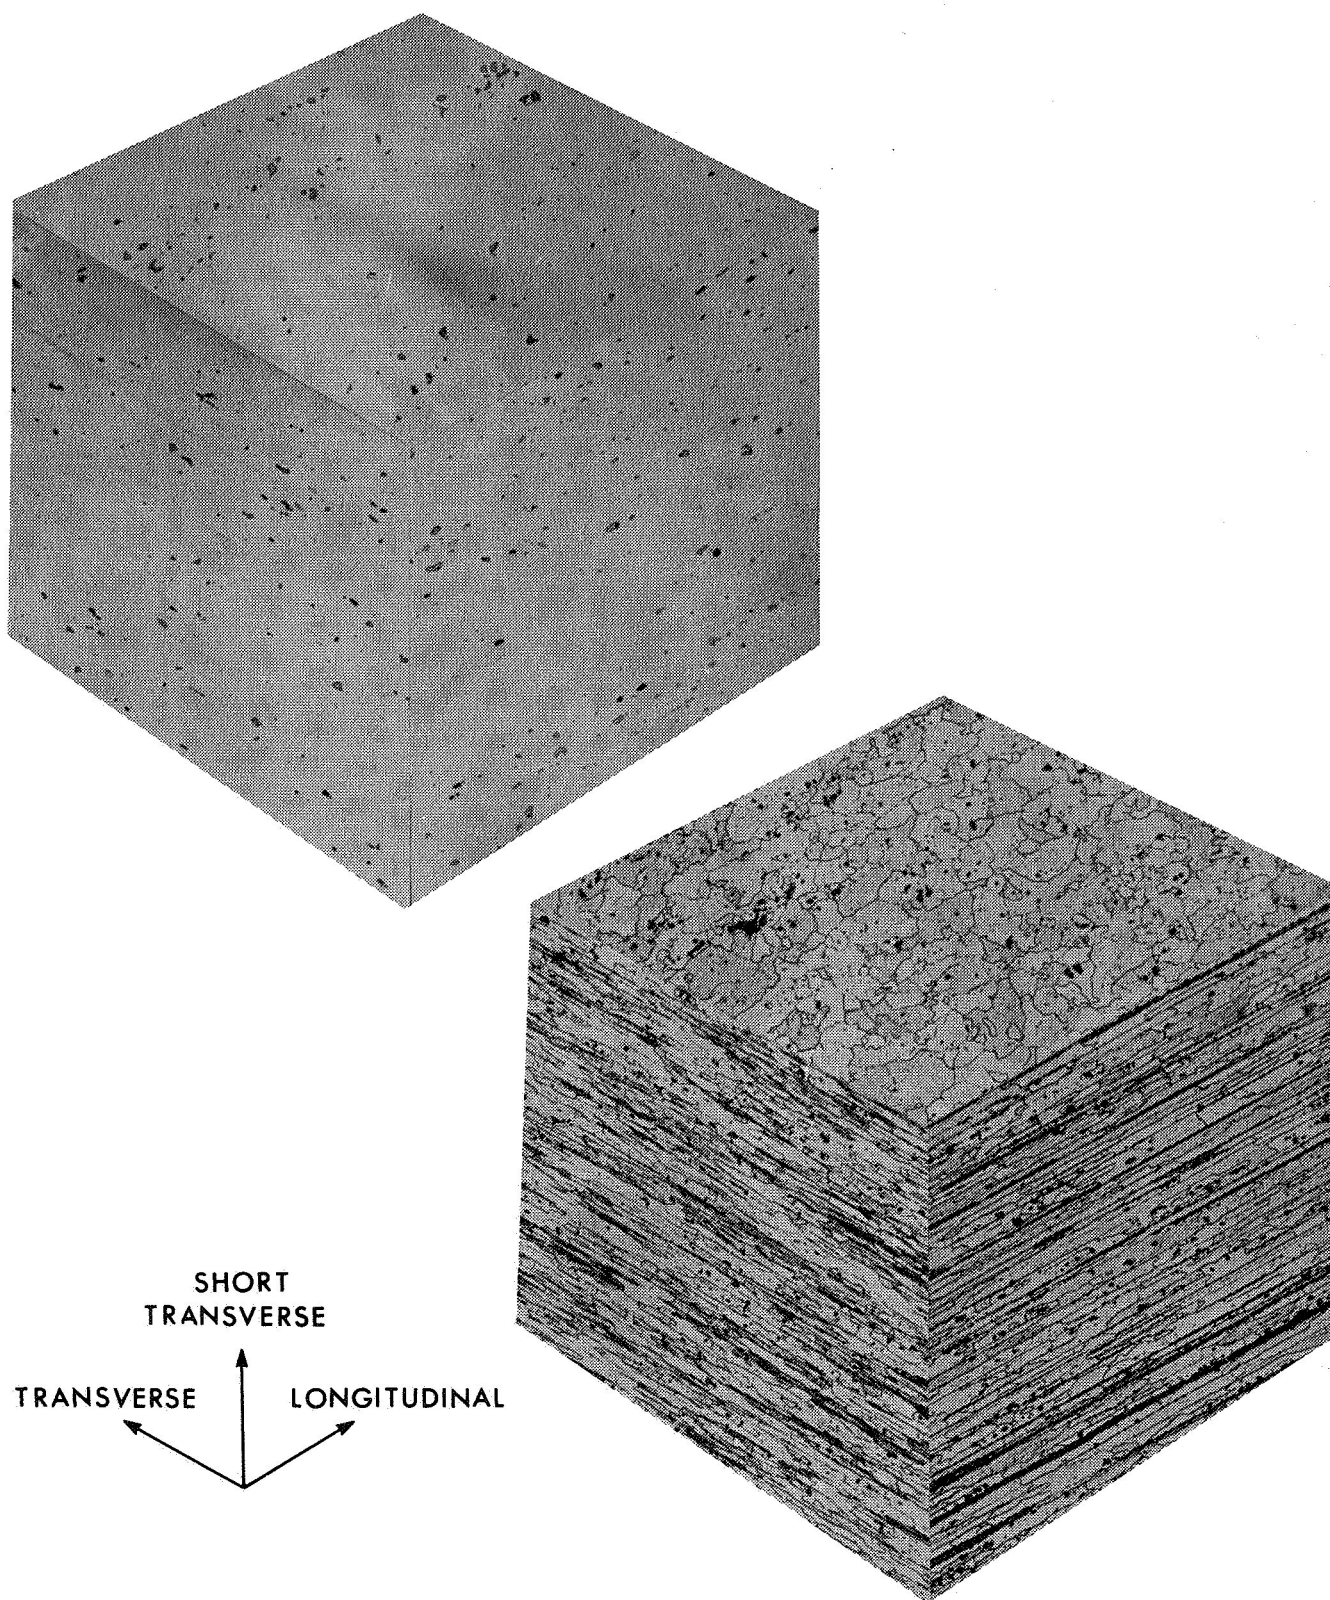
Figure 7. Light and normally etched microstructures of 0.250-inch-thick material in the peak-aged (T6) condition (Magnification 86.5X)

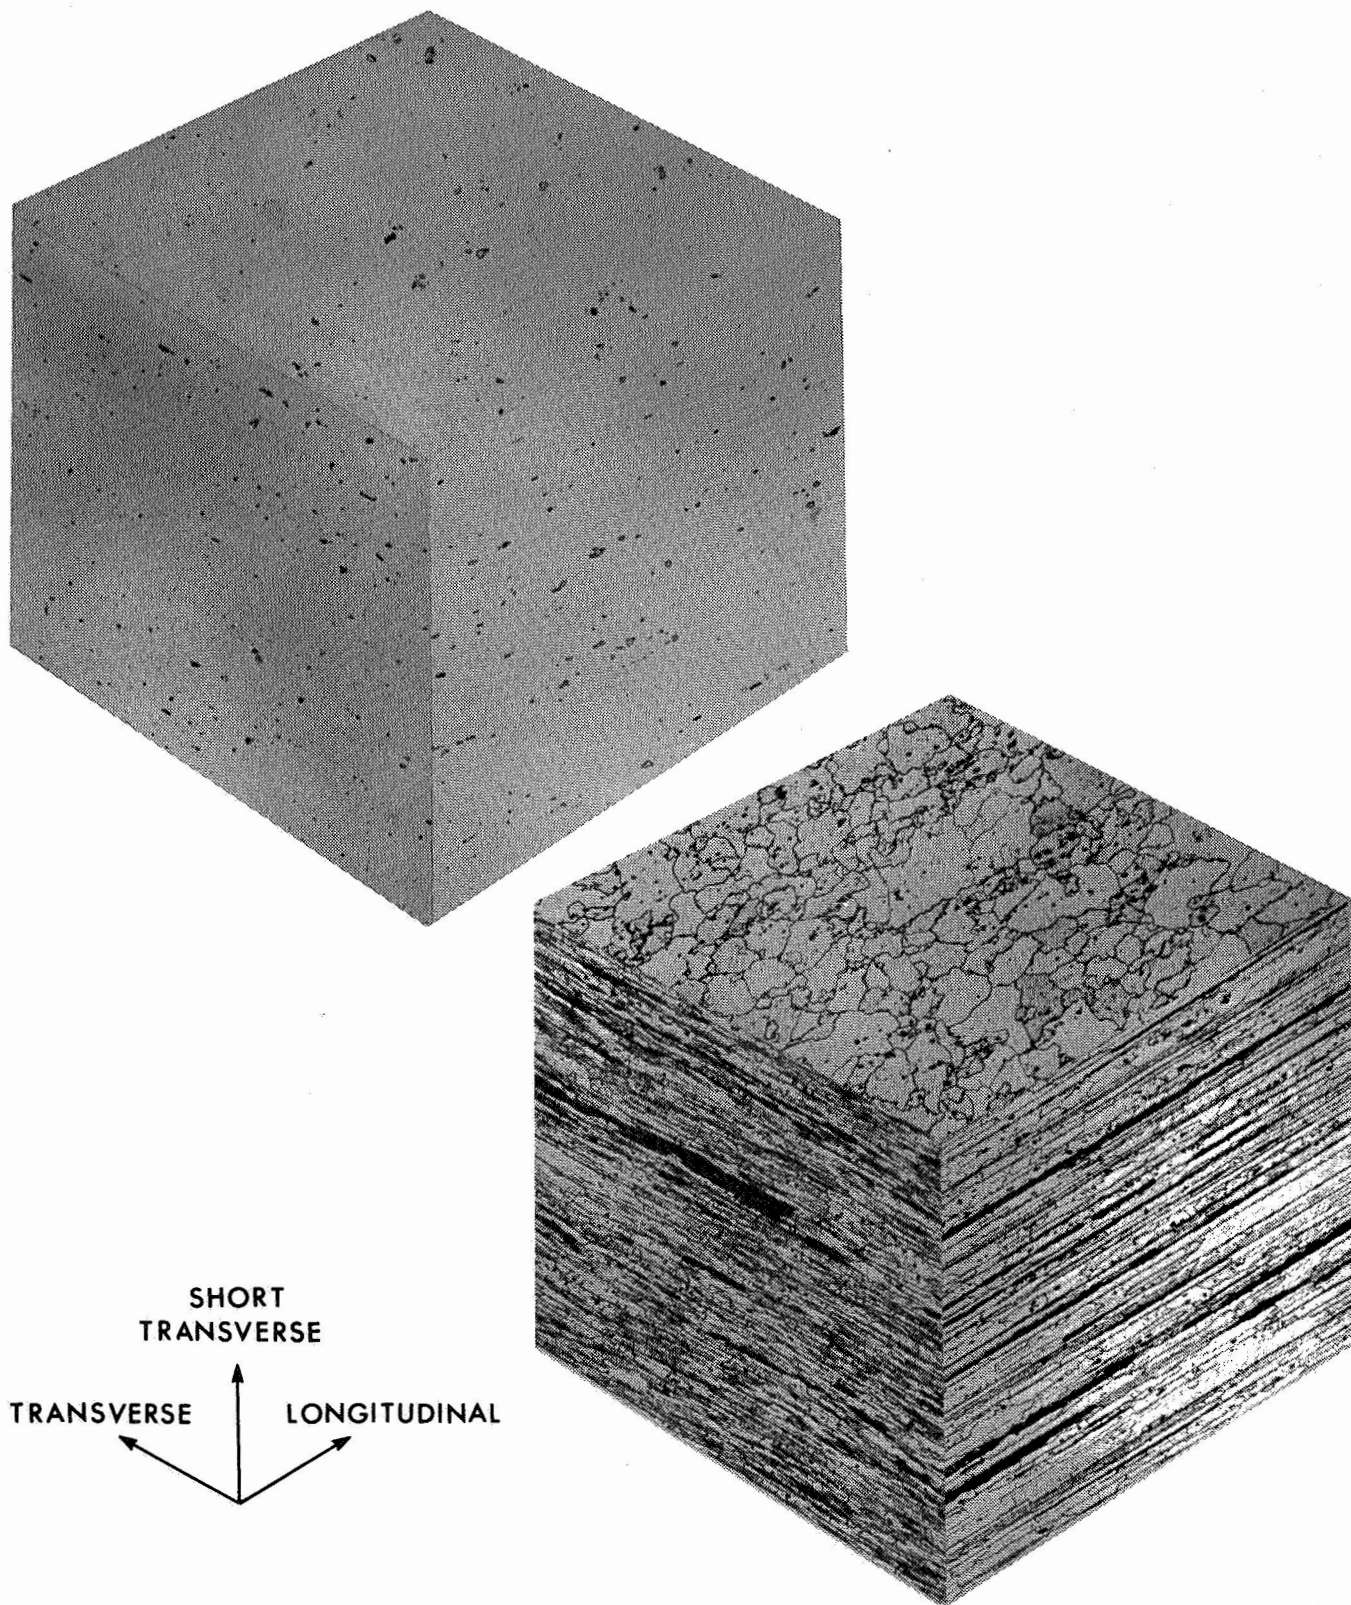
Figure 8. Light and normally etched microstructures of 0.250-inch-thick material in the overaged condition (Magnification 86.5X)

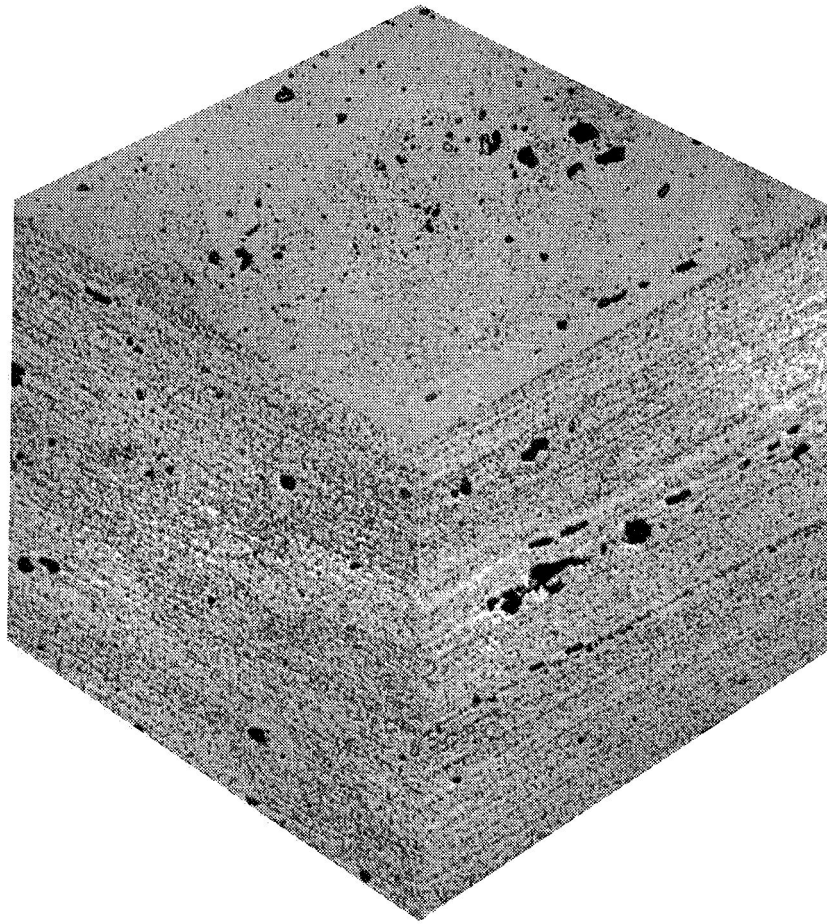
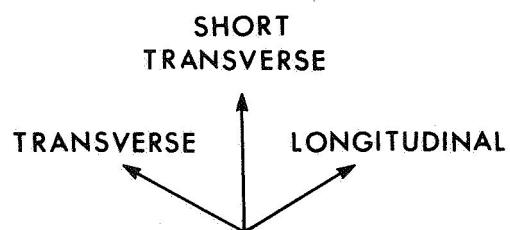
Figure 9. Microstructure of 0.25-inch-thick material in the underaged condition (Magnification 440X)

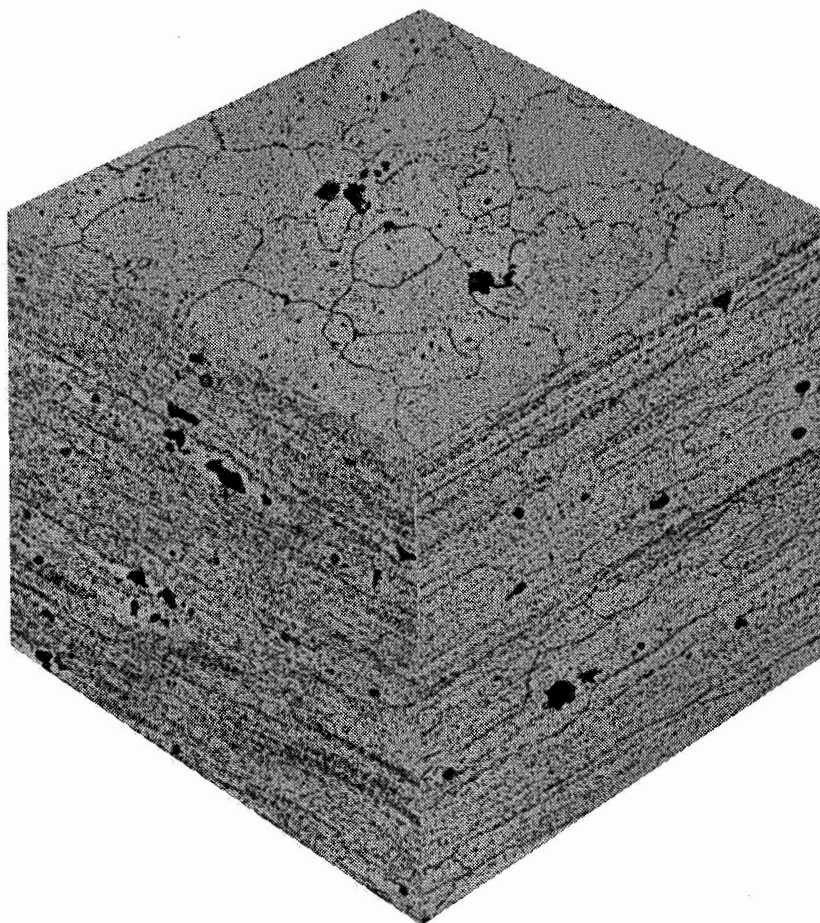
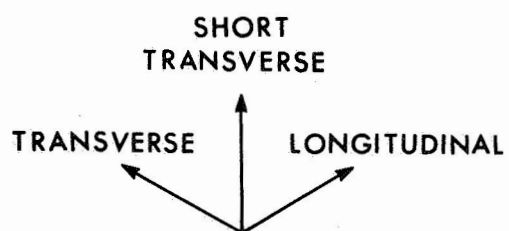
Figure 10. Microstructure of 0.25-inch-thick material in the peak-aged (T6) condition (Magnification 440X)

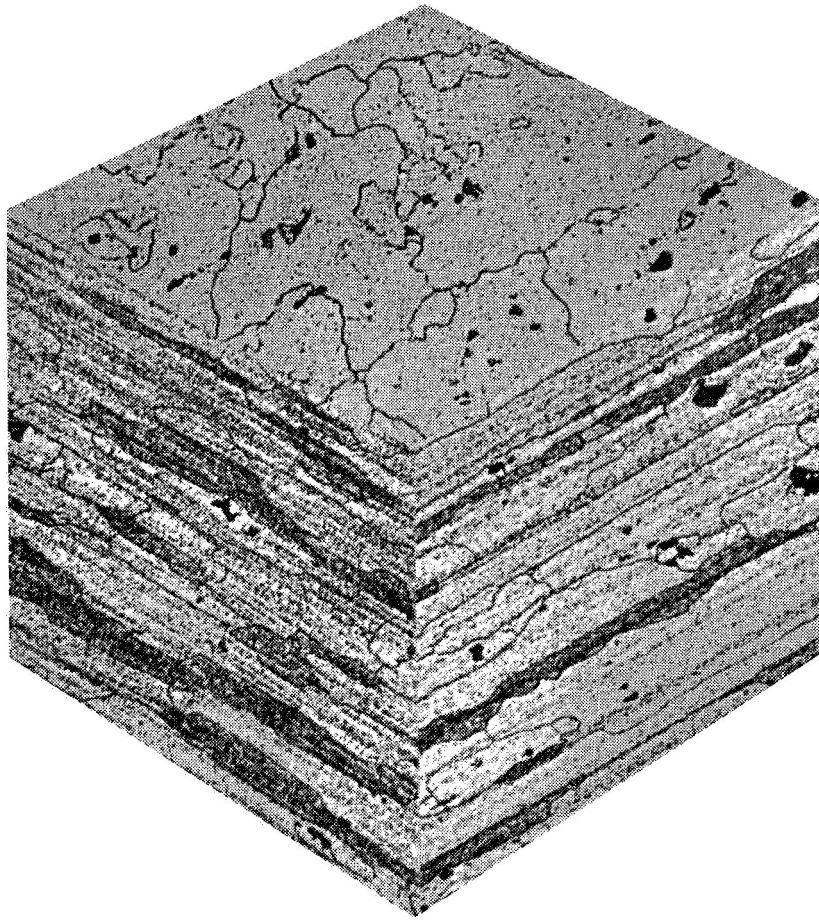
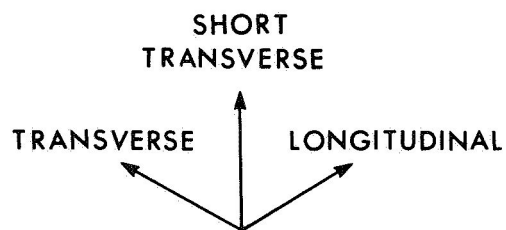
Figure 11. Microstructure of 0.25-inch-thick material in the overaged condition (Magnification 440X)

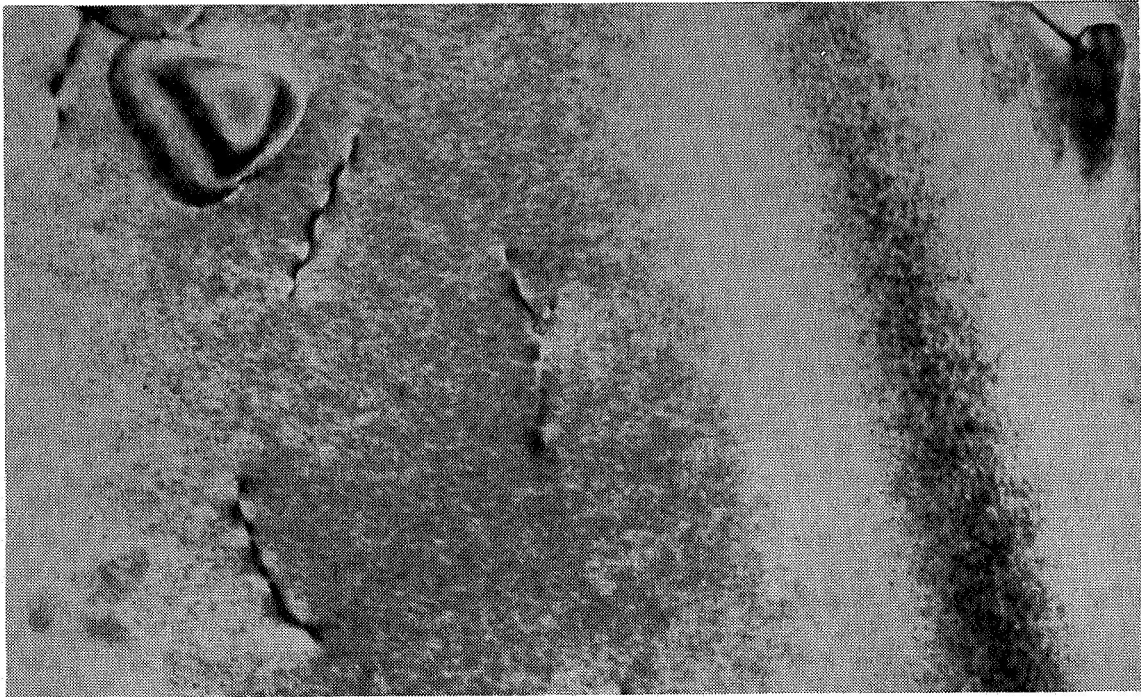
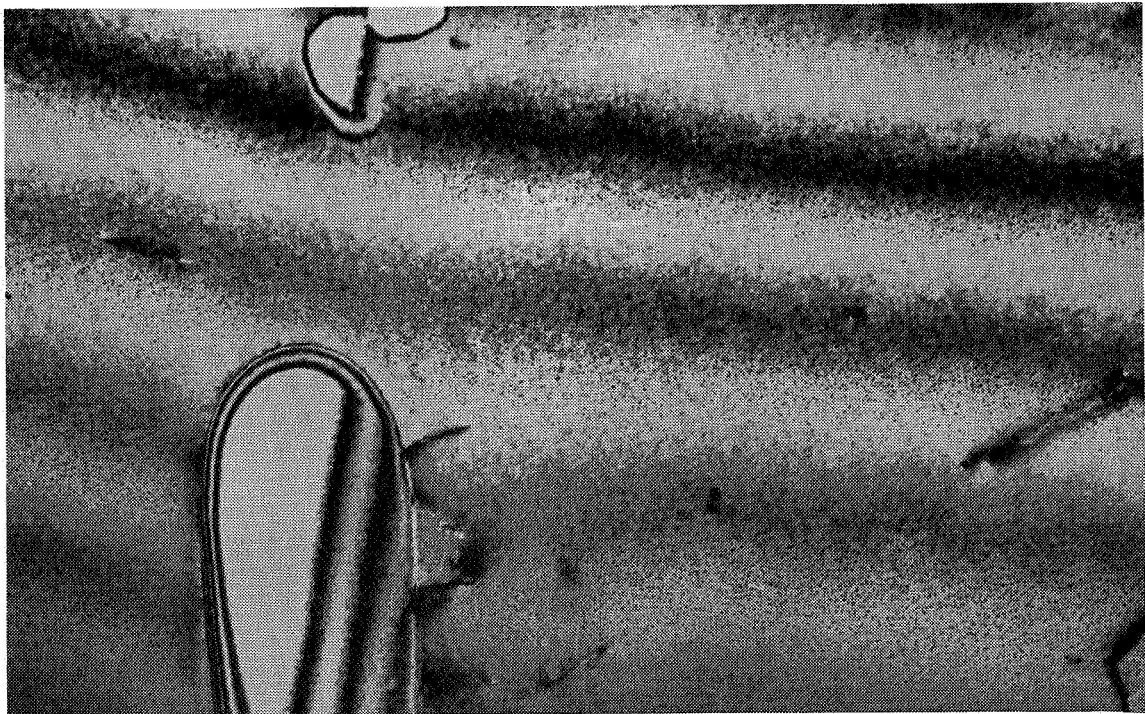
No precipitation was evident in the solution-treated, or solution-treated and room-temperature-aged specimens (figure 13), although some probably occurred during room-temperature aging as a slight increase in hardness was observed. Spherical G.P. zones were observed after a 10-minute age at elevated temperature and subsequent aging coarsened the particles (figures 14 and 15). No tendency for platelet formation was observed, and the spherical shape persisted throughout the aging sequence. No coherency strains were observed, but it is believed that the particles were originally the coherent G.P. zones and, with aging, lost coherency to form the M' and possibly the equilibrium (stable) M phase. Changes in the fracture and fatigue properties as a function of aging would be expected to be associated with the transitions from coherent to semicoherent to incoherent particles. These changes would be associated with the manner in which dislocations overcome obstacles to their motion. While the particles are coherent, passage of a dislocation through the coherent particle is possible. Once a dislocation has passed through the particle, the passage of additional dislocations through the particle on the same plane is favored, giving rise to coplanar arrays of dislocations and possible stress concentrations at pileups along grain boundaries. When the particles become incoherent, dislocation must circumvent the particles, and more tangled dislocation arrays result.

Figure 14. *Transmission electron micrographs (the hardening precipitate can be observed as a very fine scale dispersion of particles in the matrix)*

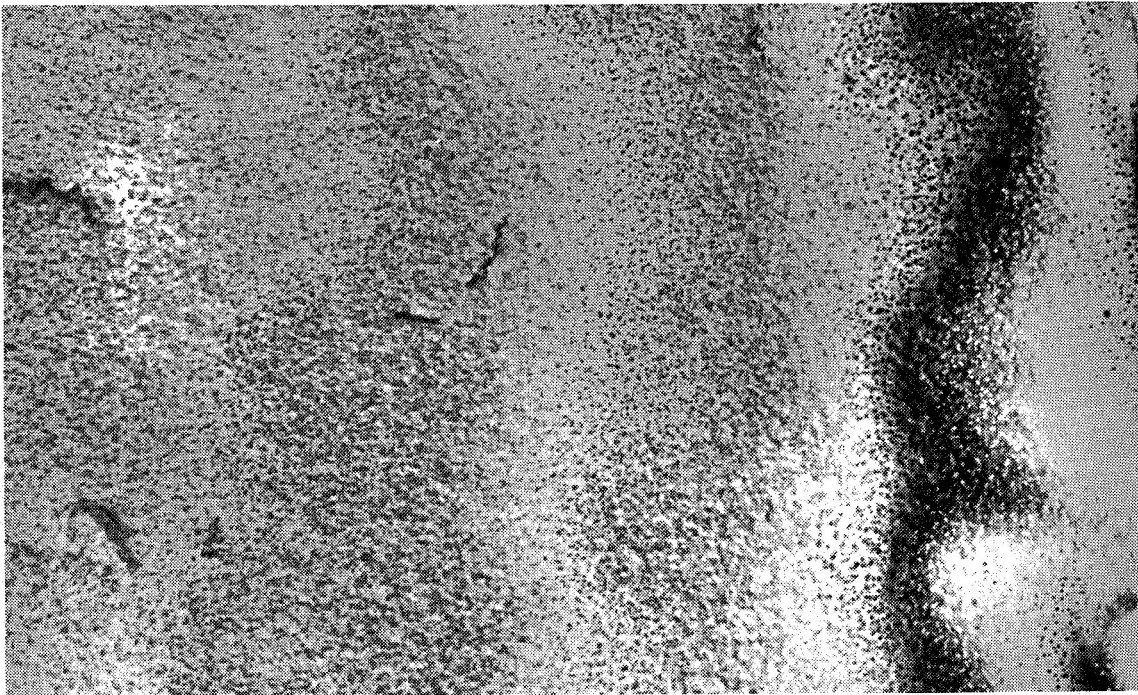
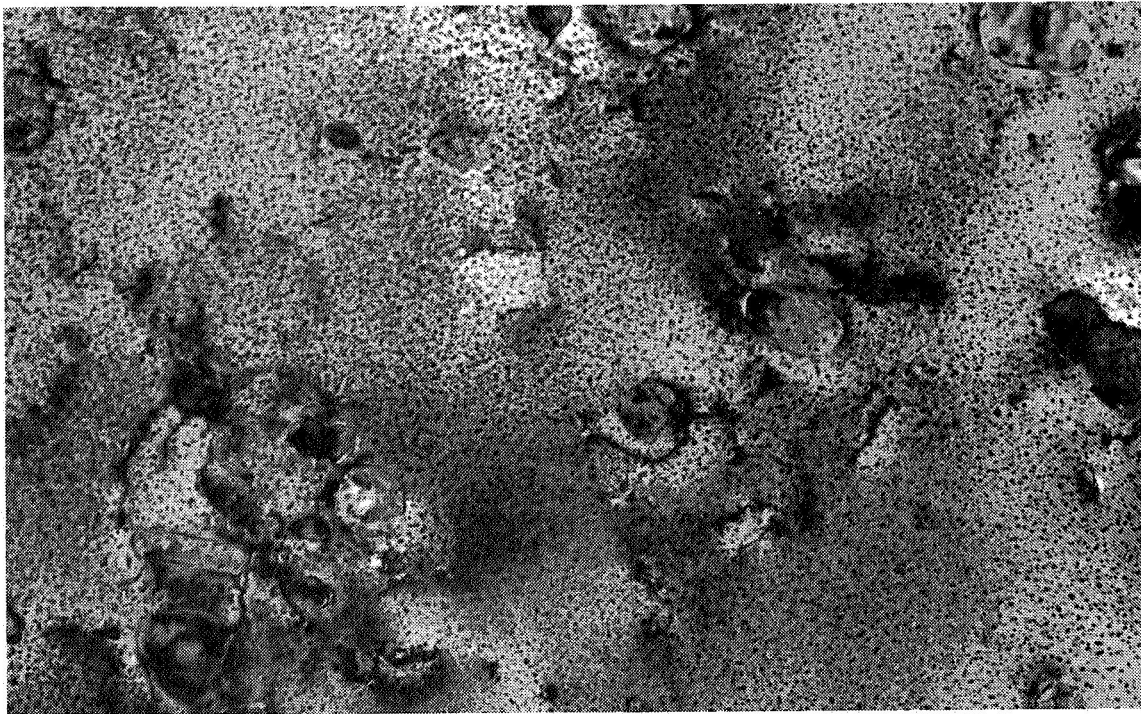
Figure 15. *Transmission electron micrographs (the hardening precipitate can be observed as a very fine scale dispersion of particles in the matrix)*

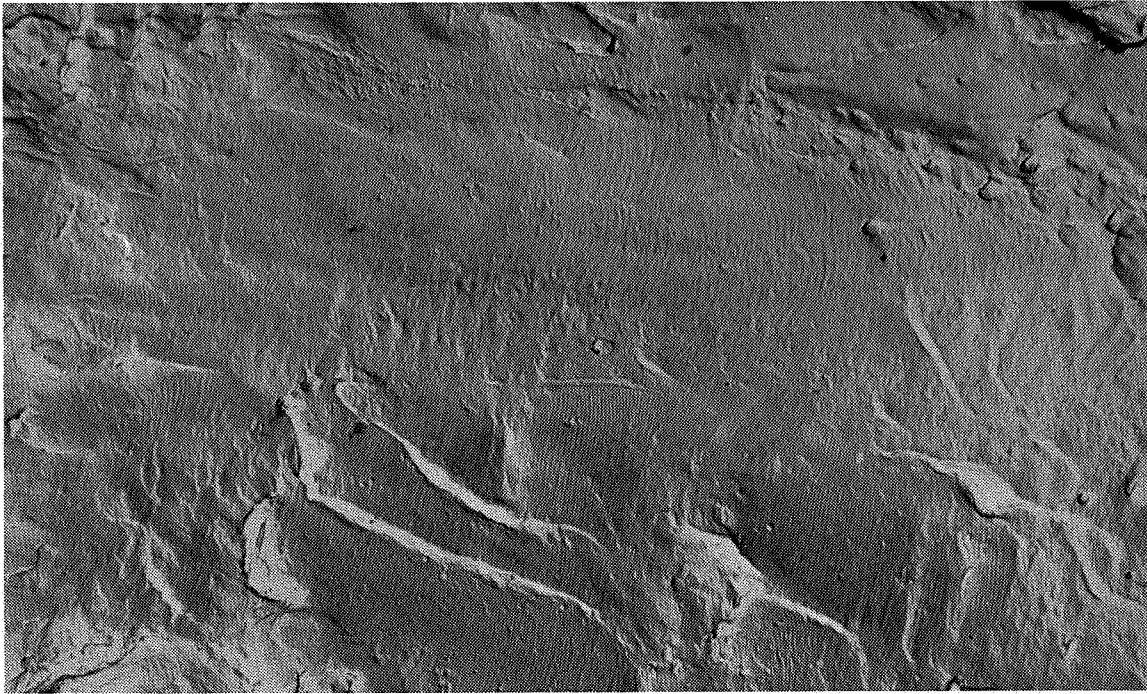
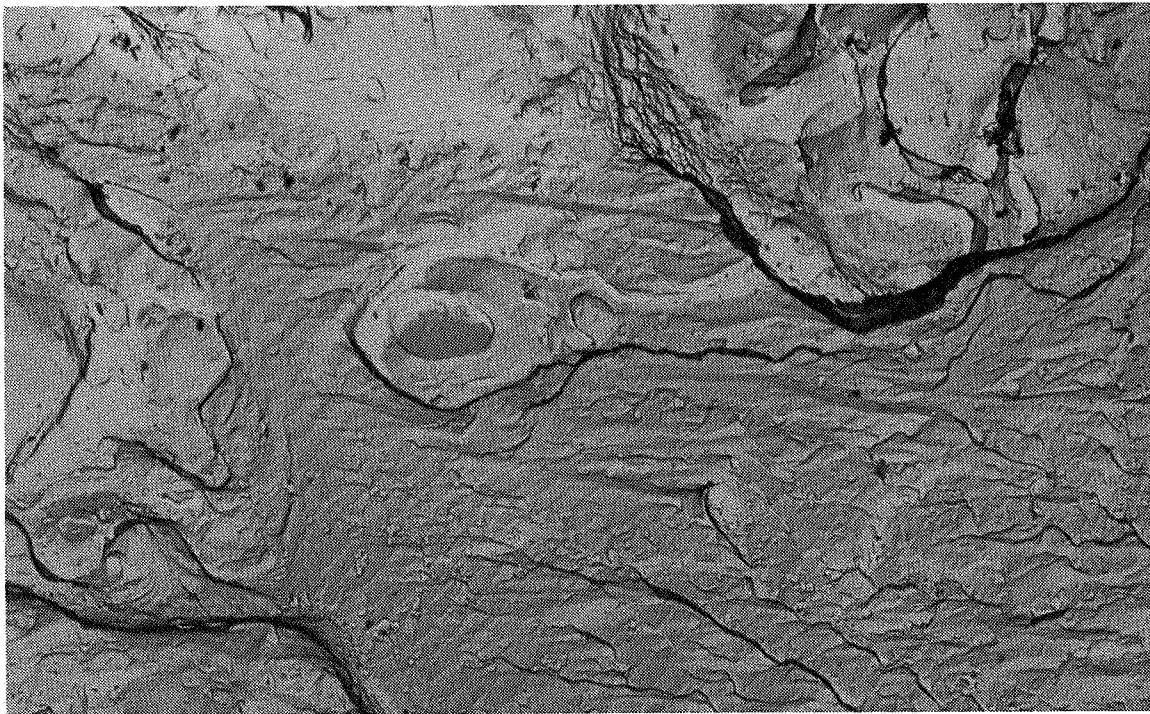
Figure 26. *Electron fractographic comparison of the fatigue-fracture mode for the 0.63-inch-thick peak-aged (T6) material at $2a = 1.5$ inches (Magnification 2850X)*

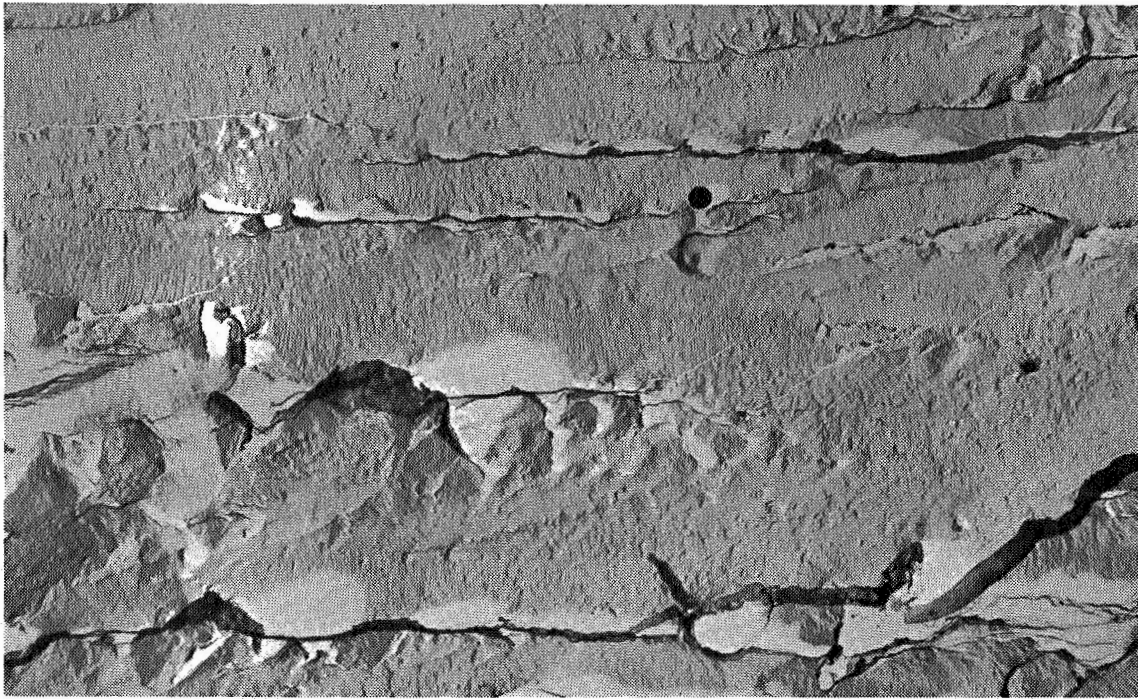
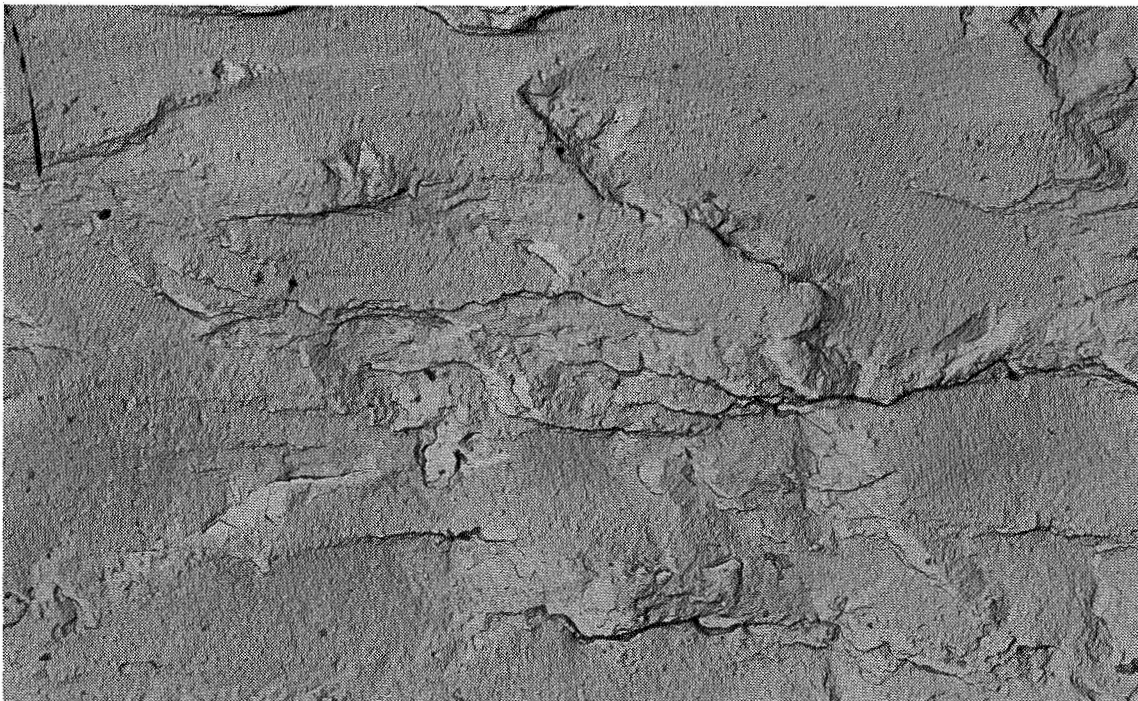
Figure 27. *Electron fractographic comparison of the fatigue-fracture mode for the 0.63-inch-thick overaged material at $2a = 1.5$ inches (Magnification 2850X)*

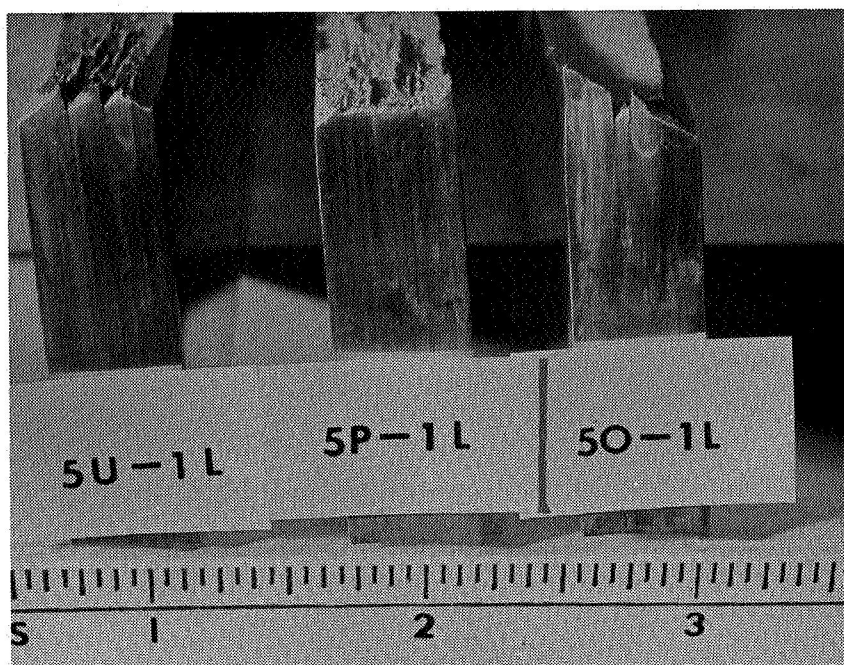
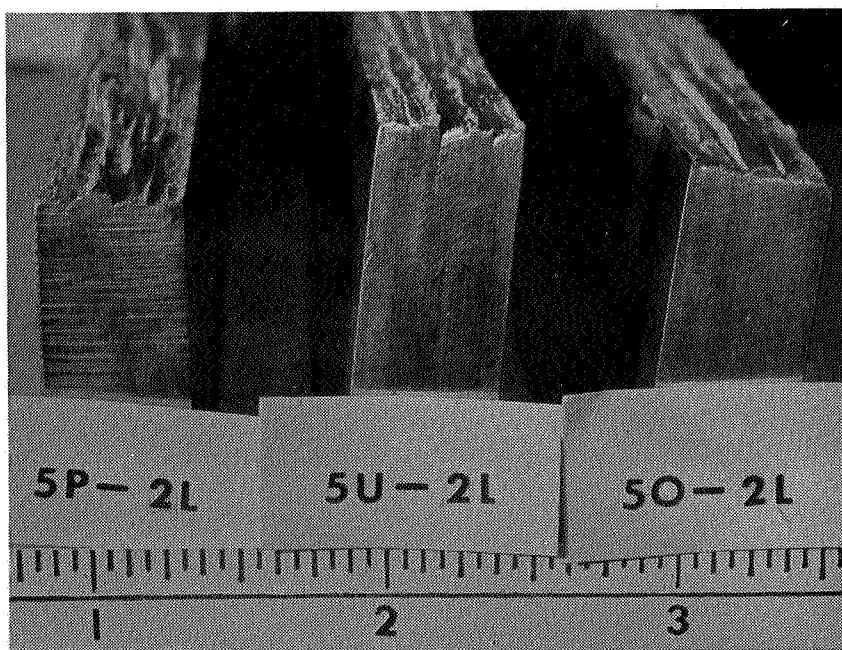
Results: The fractured specimens are shown in figure 30. The -1L specimens were fracture tested at room temperature while the -2L series was tested at -65°F. Delamination or transverse splitting was particularly pronounced on the underaged and peak-aged specimens. Low temperatures accentuated this feature and the overaged specimen also experienced transverse splitting. The delamination is most extensive at the ends and decreases toward the centers of the specimens. The extent of the delaminations at the ends of the specimens is shown in figure 31. Sections through the material show this cracking to be intergranular in nature. For comparison, sections taken 1 inch from the end of the overaged specimen tested at room temperature and underaged specimen tested at -65°F are shown in figure 32.

Figure 31. Macroscopic view of the delamination present at edge of the fracture panels after test at room temperature in dry air and at -65°F
